## Engine Testing using B10 Diesel: A case study by Kuala Lumpur City Hall (DBKL)

Nursyairah Jalil\*; Harrison Lau Lik Nang\*; Rusnani Abdul Majid\*; Ropandi Mamat\*; Daryl Jay Thardeus\*; Yung Chee Liang\*; Wan Hasamudin Wan Hassan\*; Yahaya Hawari\*; Noraida Omar\*; Astimar Abd Aziz\* and Muhammad Alif Muhamad Noor\*\*

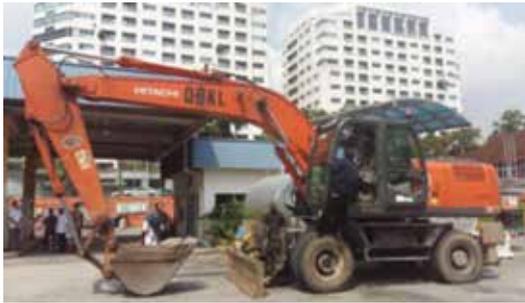
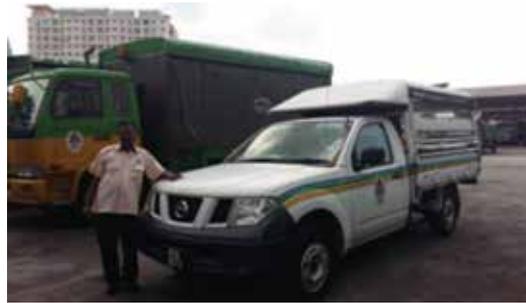
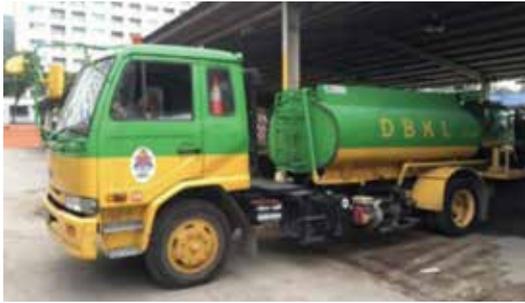
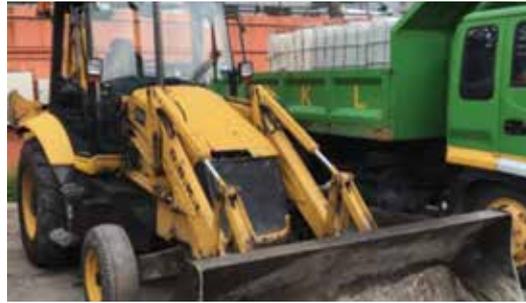
Figure 1. Some of the vehicles and machineries using B10 diesel.

a) Excavator Hitachi ZX210W-3

b) Pick-up Truck Nissan Navara

c) Water tanker Nissan LKA211N

d) Tractor Shovel, wheeled Komatsu WA200-5

With the successful implementation of B5 and B7 programme, MPOB has initiated B10 project (a blend of 10% palm biodiesel with 90% petroleum diesel) with DBKL starting in February 2014. The project involved 50 units of DBKL diesel vehicles with various brands and applications including Nissan, Komatsu, Isuzu, JCB, TCM, Ford, Mazda, Toyota, Hicom, Kia, Volvo, Weststar, Case, etc. The manufacturing years of vehicles and machineries involved in the testing were ranging from 2000 to 2013. The brands and types of vehicles and machineries in DBKL B10 Project are listed in *Table 1*. Selected images of some vehicles and machineries used are shown in *Figure 1*.

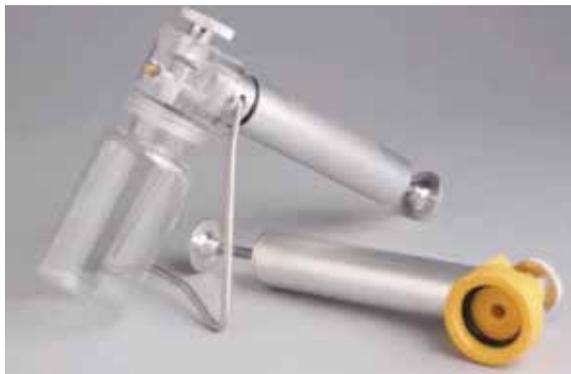
Figure 2. Extraction vacuum pump for lube oil sampling

filter and lube oil was in accordance with normal service and maintenance schedule. Lubricating oil was collected during normal oil change interval of each vehicle by using extraction vacuum pump (*Figure 2*). Sample was taken after running engine for at least 15 min to ensure homogeneity. Analysis of fresh and used engine oil were conducted by ALS Technichem (M) Sdn. Bhd. Based on the laboratory results, all lubricating oil samples showed no unusual engine wear

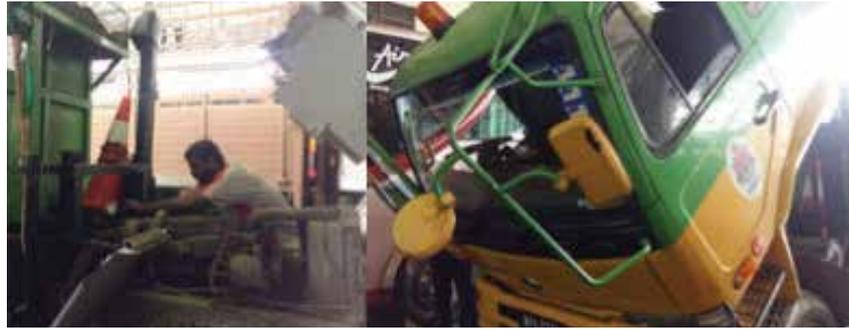
Figure 6. Engine compression test by Tan Chong Industrial Equipment (TCIE) Sdn Bhd for Nissan UD truck LKA211N (WPA9372).

Engine assessment was conducted for two selected vehicles, *i.e.* Nissan UD truck LKA211N and Nissan Navara. The objective of engine assessment was to check the condition of the engine after using B10 including fuel system and other parts that were in direct contact with the fuel. Considering the problem-free operation of the two selected vehicles, *i.e.* Nissan UD truck LKA211N with Euro2 engine (WPA9372 – 130, 000km) and Nissan Navara with Euro3 common rail engine (WXK 3673 – 90, 000km), the dealers (representing Original Equipment Manufacturers – OEM) decided that the overhaul of these vehicles will only be carried out when they reach the recommended mileages (LKA211N – 150 000 km and Navara – 100 000 km). Following the standard procedure, overhauling should only be carried out when the vehicle has a problem. While waiting for these vehicles to achieve recommended mileages, compression test and injector diagnostic test were conducted for Nissan LKA211N and Nissan Navara at dedicated Nissan service workshop. The exhaust emission test was

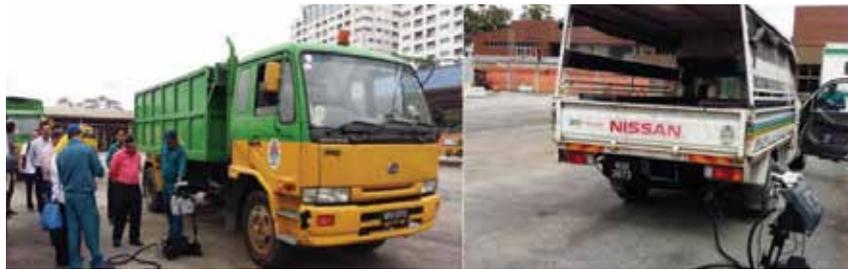
Figure 7. Smoke test by Department of Environment (DOE).

Smoke test (Figure 7) for Nissan Navara at 60 000 km and Nissan UD LKA211N at 100 000 km was conducted by Department of Environment (DOE). The results of the exhaust and smoke emissions test for

Nissan Navara and Nissan UD LKA211N were 2.7% and 2.8% respectively, which were below the maximum opacity limit of 50% set by the DOE. The tailpipe exhaust emission quality for the vehicles using B10 diesel has been greatly improved due to cleaner combustion of the fuel resulted in less smoke and unburnt hydrocarbon.

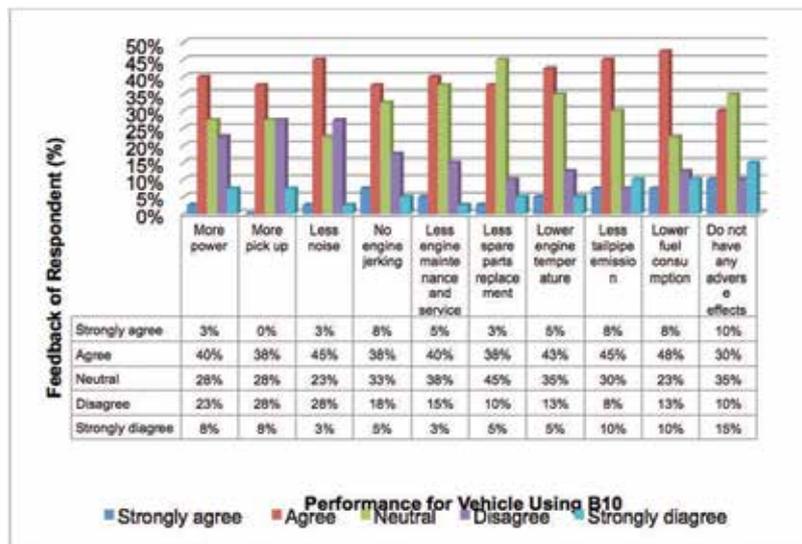
Figure 8. Performance of vehicle using B10 based on driver's experience.

Survey questionnaires have been given to all drivers to gather the experience of using B10. From the survey, it was noted that the drivers agreed that the engine performance of using B10 was comparable with engine running using normal diesel. In fact, majority of the drivers experienced better engine performance, better fuel consumption, smoother engine operation and more power when using B10 as shown in *Figure 8*.
