Aqua PUR[®]: Polyaspartic Elastomeric Coating for Palm Oil Mill Applications

Ramesh Retnasabapathy*; **Andrew Yap Kian Chung**** and **Muzzammil Ngatiman***

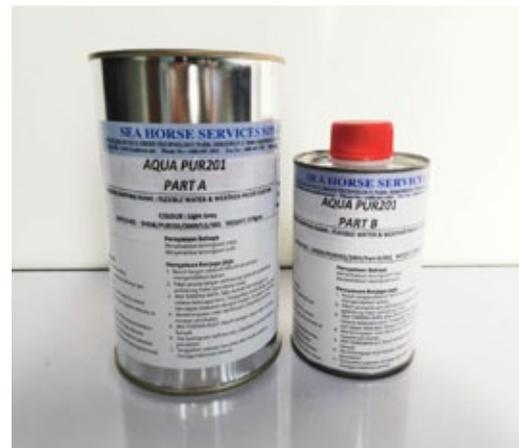
Figure 1. Aqua PUR[®] Polyaspartic elastomeric coating chemical compound.

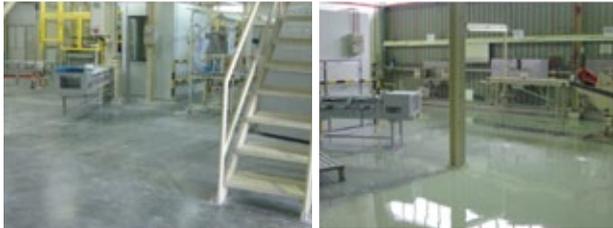
Figure 2. Example of application of seamless flooring using Aqua PUR®.

Hygiene Regulations, 2009). It is to prevent contamination due to the growth and spread of bacteria in food handling processes. Practically, for palm oil mills, the mill flooring must be able to handle high abrasion and harsh conditions to meet daily operation requirements. This is where a polyaspartic elastomeric coating can play a role in helping the industry meet this standard.

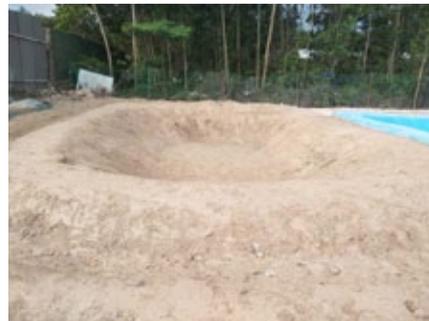
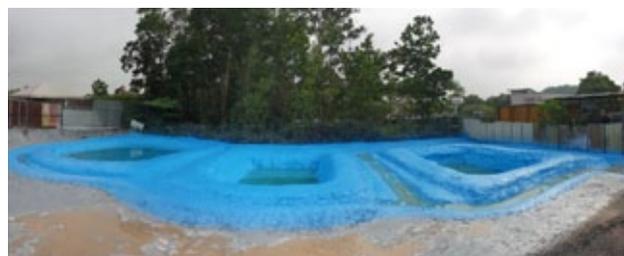
Figure 3. Unlined pond (above) and lined ponds using Aqua PUR® (below).

There is a huge potential to benefit from the application of Aqua PUR® for these important structures in palm oil mills. Lining of the POME treatment pond and its bund wall as well as slopes around the POME treatment facility has become more relevant today for environmental and structural advantages. A demonstration of its application is as shown in Figures 3 and 4. Aqua PUR® in such application has the potential to reduce the construction cost drastically and makes the structure long lasting with minimum maintenance costs.

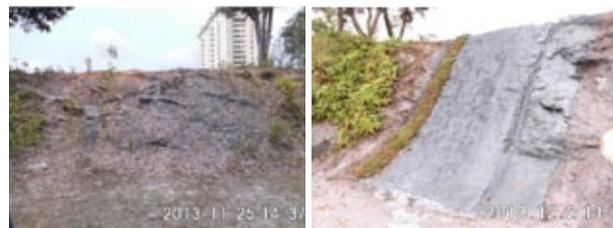
Before slope protection

After slope protection

Figure 4. Polyaspartic elastomeric coating slope protection.

An alternative option by using concrete pond construction as treatment ponds is an expensive as well as labour-intensive endeavour. Furthermore, concrete ponds may develop hairline cracks after merely months of service life due to uncontrollable shear stresses caused by earth movement. Other critical structures in a POME treatment facility are bund walls and slopes. Excessive rainfall during the monsoon season causes effluent

levels to rise and bund walls to crack which could lead to environmental contamination. Again, application of concrete and embedded beams to make the soil firm on the slope is an expensive solution.
